**Flood Control Project Maintenance  
Levee Inspections**  
**LMA District Cover Sheet**  
**Spring 2018 Levee Inspection Results**

**Sacramento Maintenance Yard West Levee Yolo Bypass**

**Spring 2018 Levee Inspection Results**

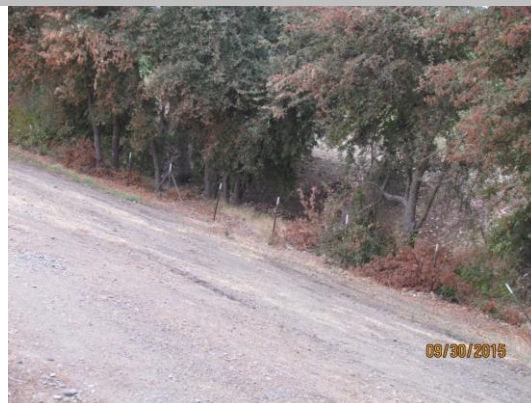
Photo 1 of 1 : SP\_2018\_ST0011\_291\_8\_20180306\_00002.jpg

LM Start	0.94	Rating **	M	Issue No.	8
LM End	1.83	Issue Type +	En	Location *	LS
Category	Earthen Levee			GPS Latitude/Longitude	
				Start	End
Item	Encroachments			38.747888 °	38.734972 °
				-121.660202 °	-121.660265 °
DWR ID	DWR_ST0011_01_s_2012_8				
Comment Code					
DT : Ditch					
Inspector Comment					
The ditch is at the toe of the levee.

View of the ditch on the landward side of the levee. Fall 2015.

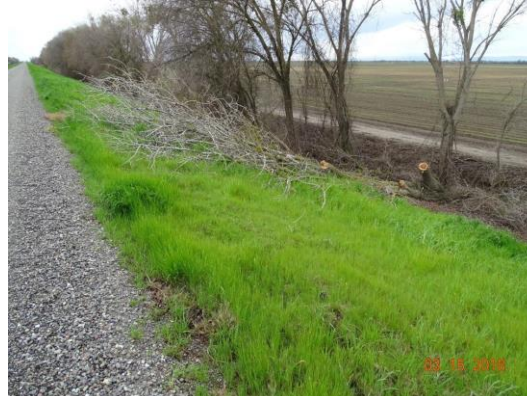
Photo 1 of 1 : SP\_2018\_ST0011\_291\_17\_20180315\_00016.jpg

View of cut tree on landside slope. Spring 2018.

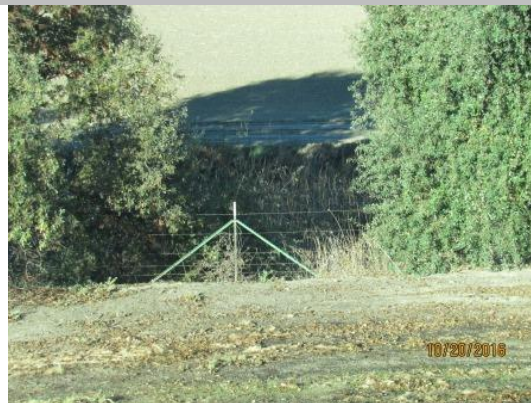
Photo 1 of 2 : SP\_2018\_ST0011\_291\_9\_20180306\_00003.jpg

View of fence along the ditch on landside. Fall 2016.

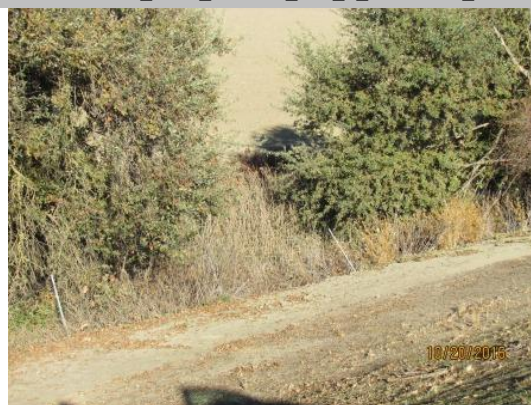
Photo 2 of 2 : SP\_2018\_ST0011\_291\_9\_20180306\_00004.jpg

Another view of fence along the ditch on landside. Fall 2016.

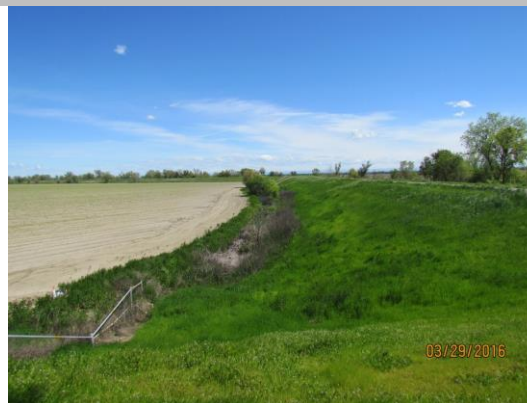
Photo 1 of 1 : SP\_2018\_ST0011\_291\_4\_20180306\_00001.jpg

View of the ditch at the toe of the levee on the landward side. Spring 2016.

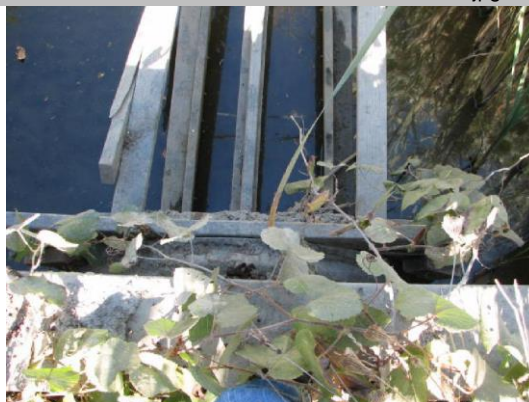
Photo 2 of 3 : UCIP\_SP\_2018\_52501\_60303.jpg

Comment Code						
Inspector Comment						
FS_ID:52501 DS_ID:17742 EP_NO: 10284 Repair Type: No Action Needed Crossing Status: Found UCIP Comments: Screw gates where removed and pipe was abanded by farmer, How pipe was abanded is unknown. FIELD_STRUCT_DESC: 1 of 2: 42-inch corrugated metal gravity drainage pipe through the levee, 23.6 feet below the crown. Slide gate on the waterside (WS) slope. Concrete distribution box at the landside (LS) toe. (42-inch pipe [HLM 2.63] authorized under Automatic Board Order (ABO) issued as Permit No. 10284, 1974 - La Borda and Hoover). [Additional Reference(s): DWR Levee Log, 2004. USACE Sacramento O&M Manual 127, June 1953, (Station 133+82)]. FS Date: 11/16/2017 1:59:55 PM

Landside view: concrete spillbox/headwall and pipe (top view)

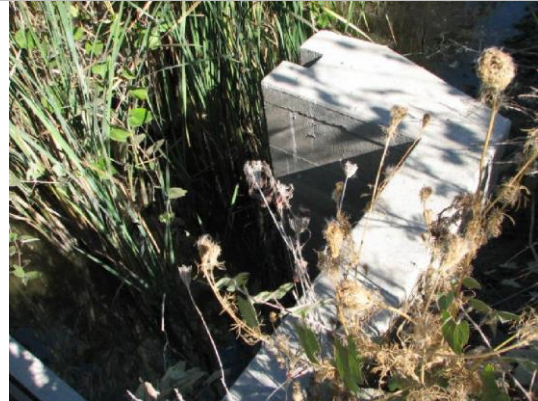
Photo 3 of 3 : UCIP\_SP\_2018\_52501\_60302.jpg

Comment Code						
Inspector Comment						
FS_ID:52501 DS_ID:17742 EP_NO: 10284 Repair Type: No Action Needed Crossing Status: Found UCIP Comments: Screw gates where removed and pipe was abanded by farmer, How pipe was abanded is unknown. FIELD_STRUCT_DESC: 1 of 2: 42-inch corrugated metal gravity drainage pipe through the levee, 23.6 feet below the crown. Slide gate on the waterside (WS) slope. Concrete distribution box at the landside (LS) toe. (42-inch pipe [HLM 2.63] authorized under Automatic Board Order (ABO) issued as Permit No. 10284, 1974 - La Borda and Hoover). [Additional Reference(s): DWR Levee Log, 2004. USACE Sacramento O&M Manual 127, June 1953, (Station 133+82)]. FS Date: 11/16/2017 1:59:55 PM

Landside view: side of concrete spillbox/headwall

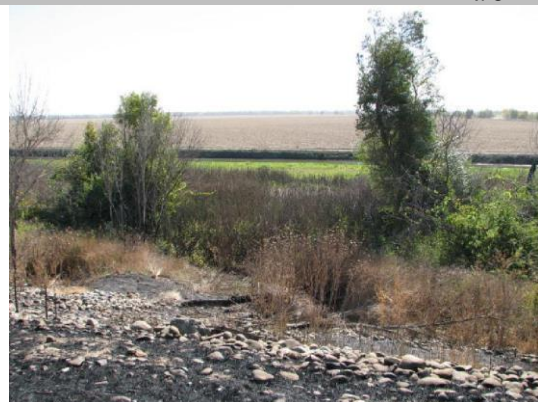
Photo 1 of 3 : UCIP\_SP\_2018\_52502\_60309.jpg

Comment Code						
Inspector Comment						
FS_ID:52502 DS_ID:17747 EP_NO: 10284 Repair Type: No Action Needed Crossing Status: Found UCIP Comments: No slide gate found. slide gates and pipes were abandon by farmer, how unknown FIELD_STRUCT_DESC: 2 of 2: 42-inch corrugated metal gravity drainage pipe through the levee, 23.6 feet below the crown. Slide gate on the waterside (WS) slope. Concrete distribution box at the landside (LS) toe. (42-inch pipe [HLM 2.63] authorized under Automatic Board Order (ABO) issued as Permit No. 10284, 1974 - La Borda and Hoover). [Additional Reference(s): DWR Levee Log, 2004. USACE Sacramento O&M Manual 127, June 1953, (Station 133+82)]. FS Date: 11/16/2017 2:01:58 PM

Waterside view: overview

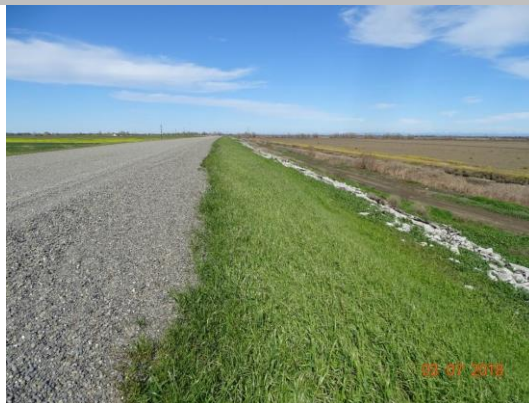
Photo 1 of 1 : SP\_2018\_ST0011\_292\_6\_20180308\_00012.jpg

View of vegetation on the waterside slope. Spring 2018.

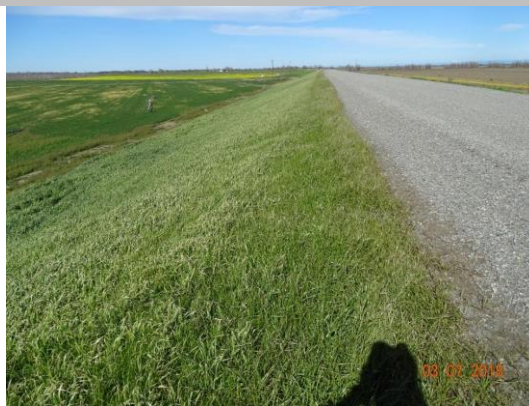
Photo 1 of 1 : SP\_2018\_ST0011\_292\_4\_20180308\_00013.jpg

LM Start	0.00	Rating **	M	Issue No.	4
LM End	1.51	Issue Type +	Ma	Location *	LS
Category	Earthen Levee			GPS Latitude/Longitude	
				Start	End
Item	Vegetation			38.718993 °	38.698736 °
				-121.664099 °	-121.674146 °
DWR ID	DWR_ST0011_02_s_2018_4				
Comment Code					
V1 : Control annual grass and weeds on the levee slopes and easements.					
Inspector Comment

View of vegetation on the landside slope. Spring 2018.

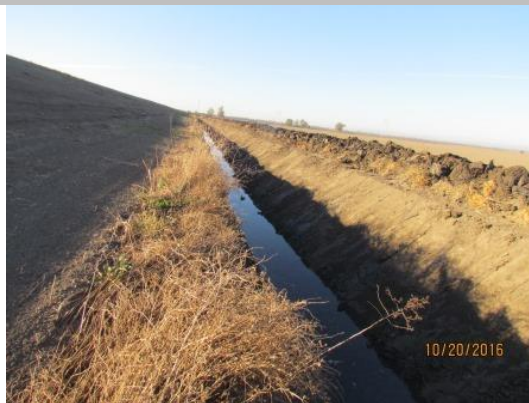
Photo 2 of 3 : SP\_2018\_ST0011\_292\_3\_20180306\_00008.jpg

View of the ditch on landward side. Ditch was deepened to approximately 10 ft. Fall 2016.

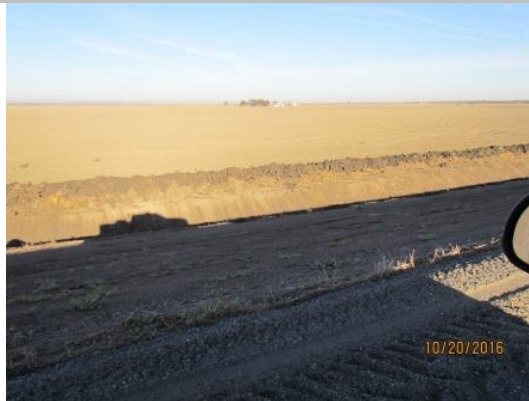
Photo 3 of 3 : SP\_2018\_ST0011\_292\_3\_20180306\_00009.jpg

View of the ditch on landward side. Fall 2016.

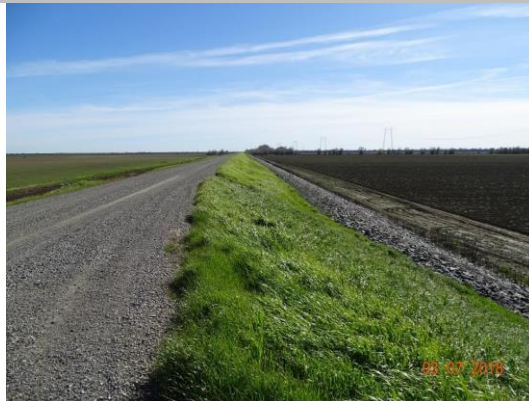
Photo 1 of 1 : SP\_2018\_ST0011\_293\_4\_20180308\_00011.jpg

View of vegetation on the landside slope. Spring 2018.

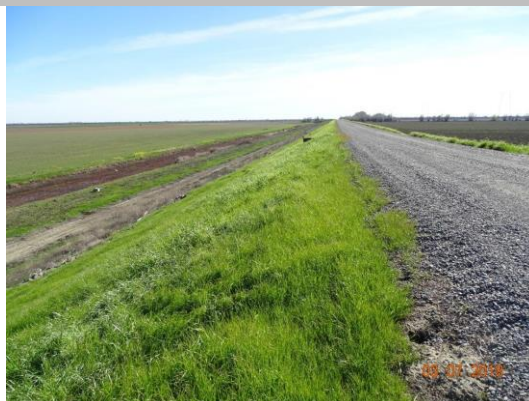
Photo 1 of 1 : SP\_2018\_ST0011\_293\_5\_20180308\_00010.jpg

LM Start	0.00	Rating **	M	Issue No.	5
LM End	1.48	Issue Type +	Ma	Location *	WS
Category	Earthen Levee			GPS Latitude/Longitude	
				Start	End
Item	Vegetation			38.698541 °	38.677231 °
				-121.674118 °	-121.672803 °
DWR ID	DWR_ST0011_03_s_2018_5				
Comment Code					
V1 : Control annual grass and weeds on the levee slopes and easements.					
Inspector Comment

View of vegetation on the waterside slope. Spring 2018.

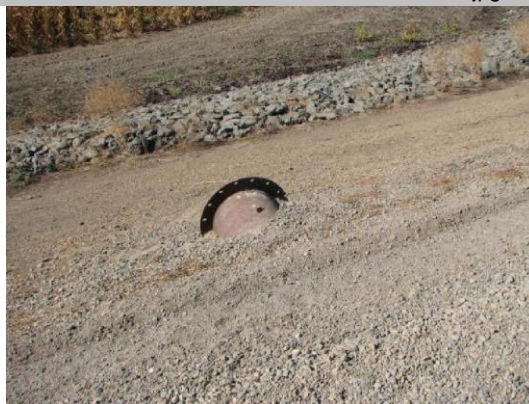
Photo 2 of 3 : UCIP\_SP\_2018\_52507\_60377.jpg

Landside view: an abandoned steel pipe.

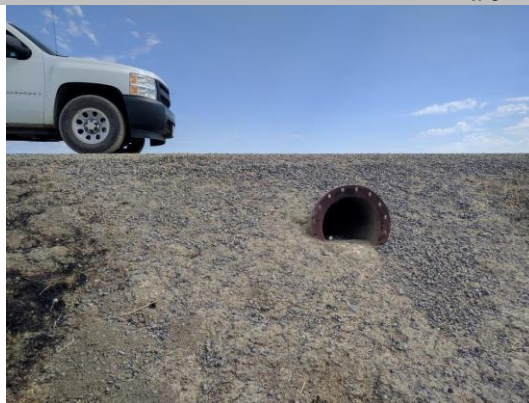
Photo 3 of 3 : UCIP\_SP\_2018\_52507\_77496.jpg

LM Start	0.03	Rating **	M	Issue No.	6 (cont)	
LM End	0.03	Issue Type +	En	Location *		
Category	Supplemental			GPS Latitude/Longitude		
				Start	End	
Item	DWR UCIP Field Study			38.698204 °	38.698204 °	
				-121.674080 °	-121.674080 °	
DWR ID						
Comment Code						
Inspector Comment						
FS_ID:52507						
DS_ID:17756						
EP_NO: N/A						
Repair Type: Non-Urgent						
Crossing Status: Found						
UCIP Comments: Pipe not properly abandoned.						
FIELD_STRUCT_DESC: *ABANDONED* 18-inch steel irrigation or drainage pipe through the levee, 3 feet below the crown.						
FS Date: 11/16/2017 2:23:11 PM

LS: straight through pipe without any gates preventing water from WS to LS.

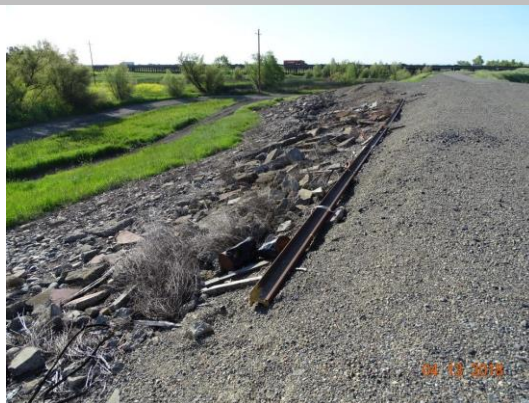
Photo 1 of 3 : SP\_2018\_ST0011\_294\_25\_20180413\_00032.jpg

LM Start	0.59	Rating **	M	Issue No.	25
LM End	0.59	Issue Type +	En	Location *	WS
Category	Earthen Levee			GPS Latitude/Longitude	
				Start	End
Item	Encroachments			38.565800 °	38.565800 °
				-121.638669 °	-121.638669 °
DWR ID	DWR_ST0011_04_s_2017_25				
Comment Code					
EQ : Equipment					
Inspector Comment					
It appears that the majority of railroad equipment was removed after the crossing repair. However, there are still tracks and debris on the waterside slope.

Updated view of equipment on the waterside shoulder. Spring 2018.

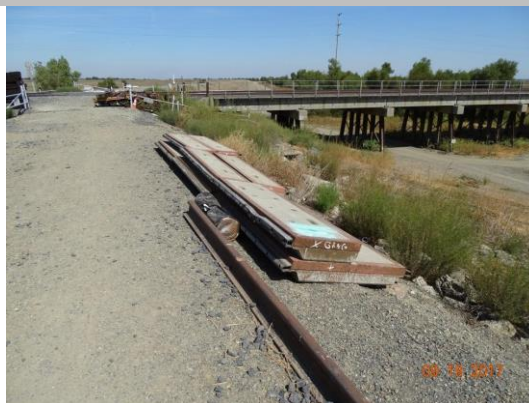
Photo 2 of 3 : SP\_2018\_ST0011\_294\_25\_20180306\_00018.jpg

View of railroad equipment on waterside shoulder. Fall 2017.

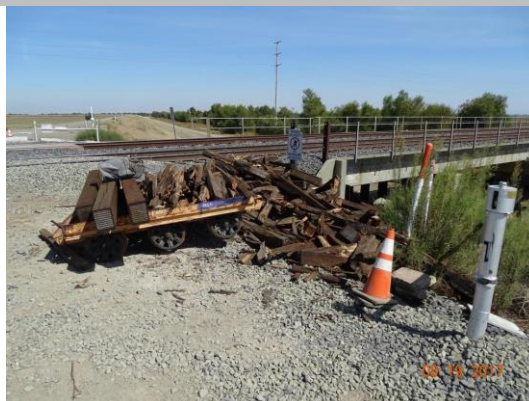
Photo 3 of 3 : SP\_2018\_ST0011\_294\_25\_20180306\_00019.jpg

Additional equipment on the waterside shoulder. Fall 2017.

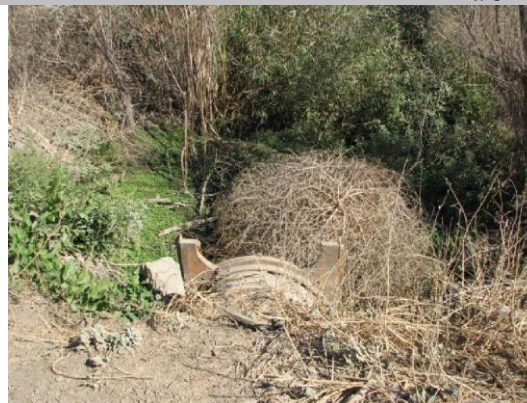
Photo 1 of 3 : UCIP\_SP\_2018\_52492\_60527.jpg

Repair Type: Urgent

Waterside view: overview

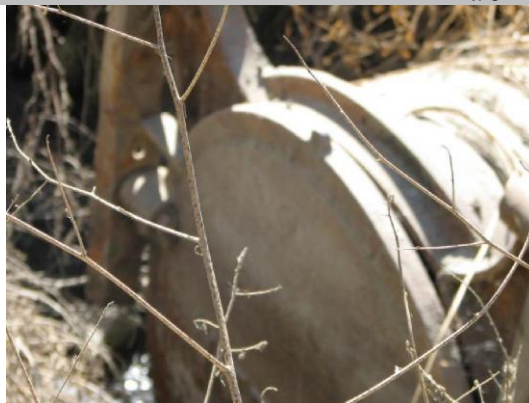
Photo 3 of 3 : UCIP\_SP\_2018\_52492\_60524.jpg

Waterside view: closer look at pipe and flap gate

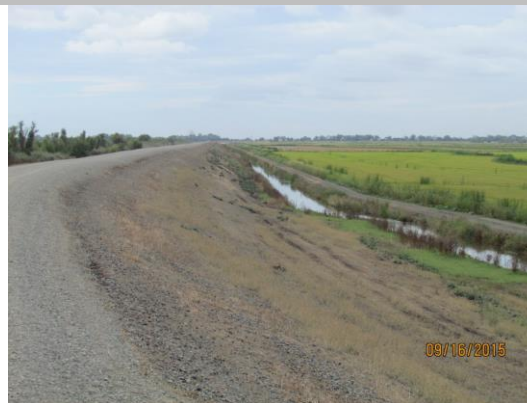
Photo 1 of 1 : SP\_2018\_ST0011\_294\_3\_20180306\_00001.jpg

View of the ditch along the levee toe on the landward side of the levee looking downstream. Fall 2015.

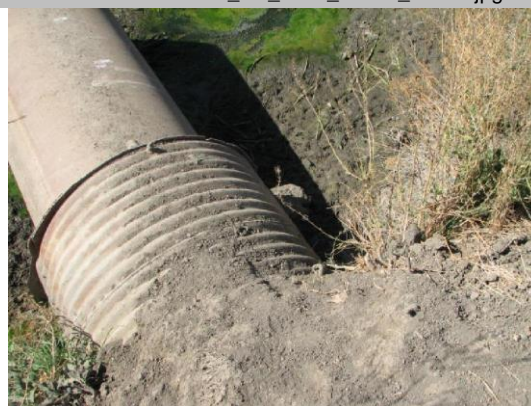
Photo 3 of 3 : UCIP\_SP\_2018\_44822\_24978.jpg

Landside view: closer look at 42-inch steel pipe and 48-inch CMP

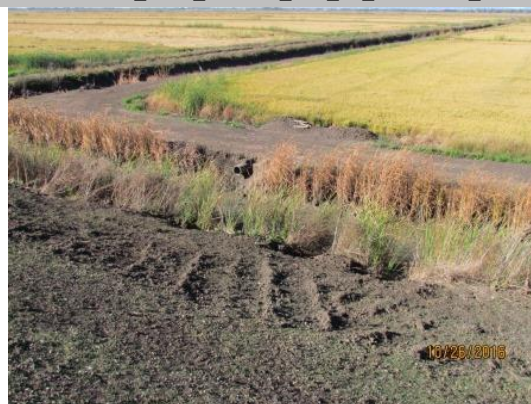
Photo 1 of 2 : SP\_2018\_ST0011\_294\_19\_20180306\_00015.jpg

View of erosion on landside levee slope. Fall 2016.

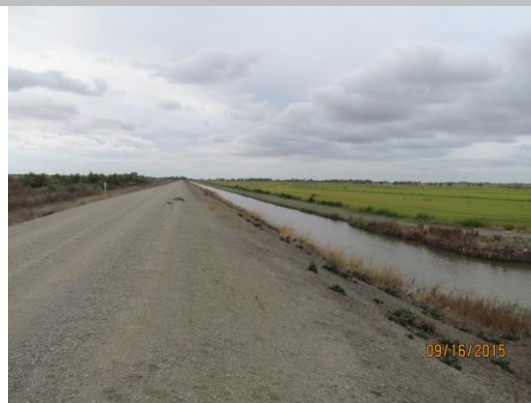
Photo 1 of 2 : SP\_2018\_ST0011\_294\_4\_20180306\_00002.jpg

The ditch is at the levee toe on the landward side of the levee looking downstream. Fall 2015.

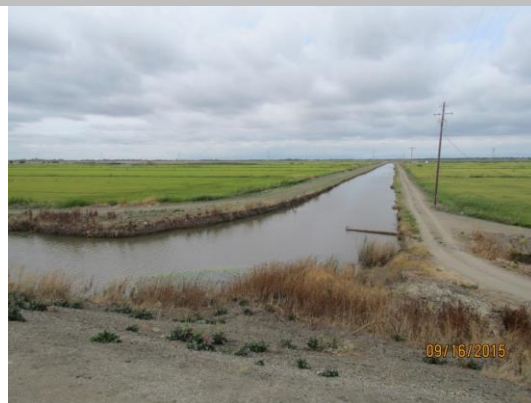
Photo 2 of 2 : SP\_2018\_ST0011\_294\_4\_20180306\_00003.jpg

Looking west at the agricultural ditch. Fall 2015.
